Debris/Ice/TPS Assessment And Integrated Photographic Analysis For Shuttle Mission STS-45

May 1992

Gregory N. Katnik
NASA/Kennedy Space Center

March 24, 1992

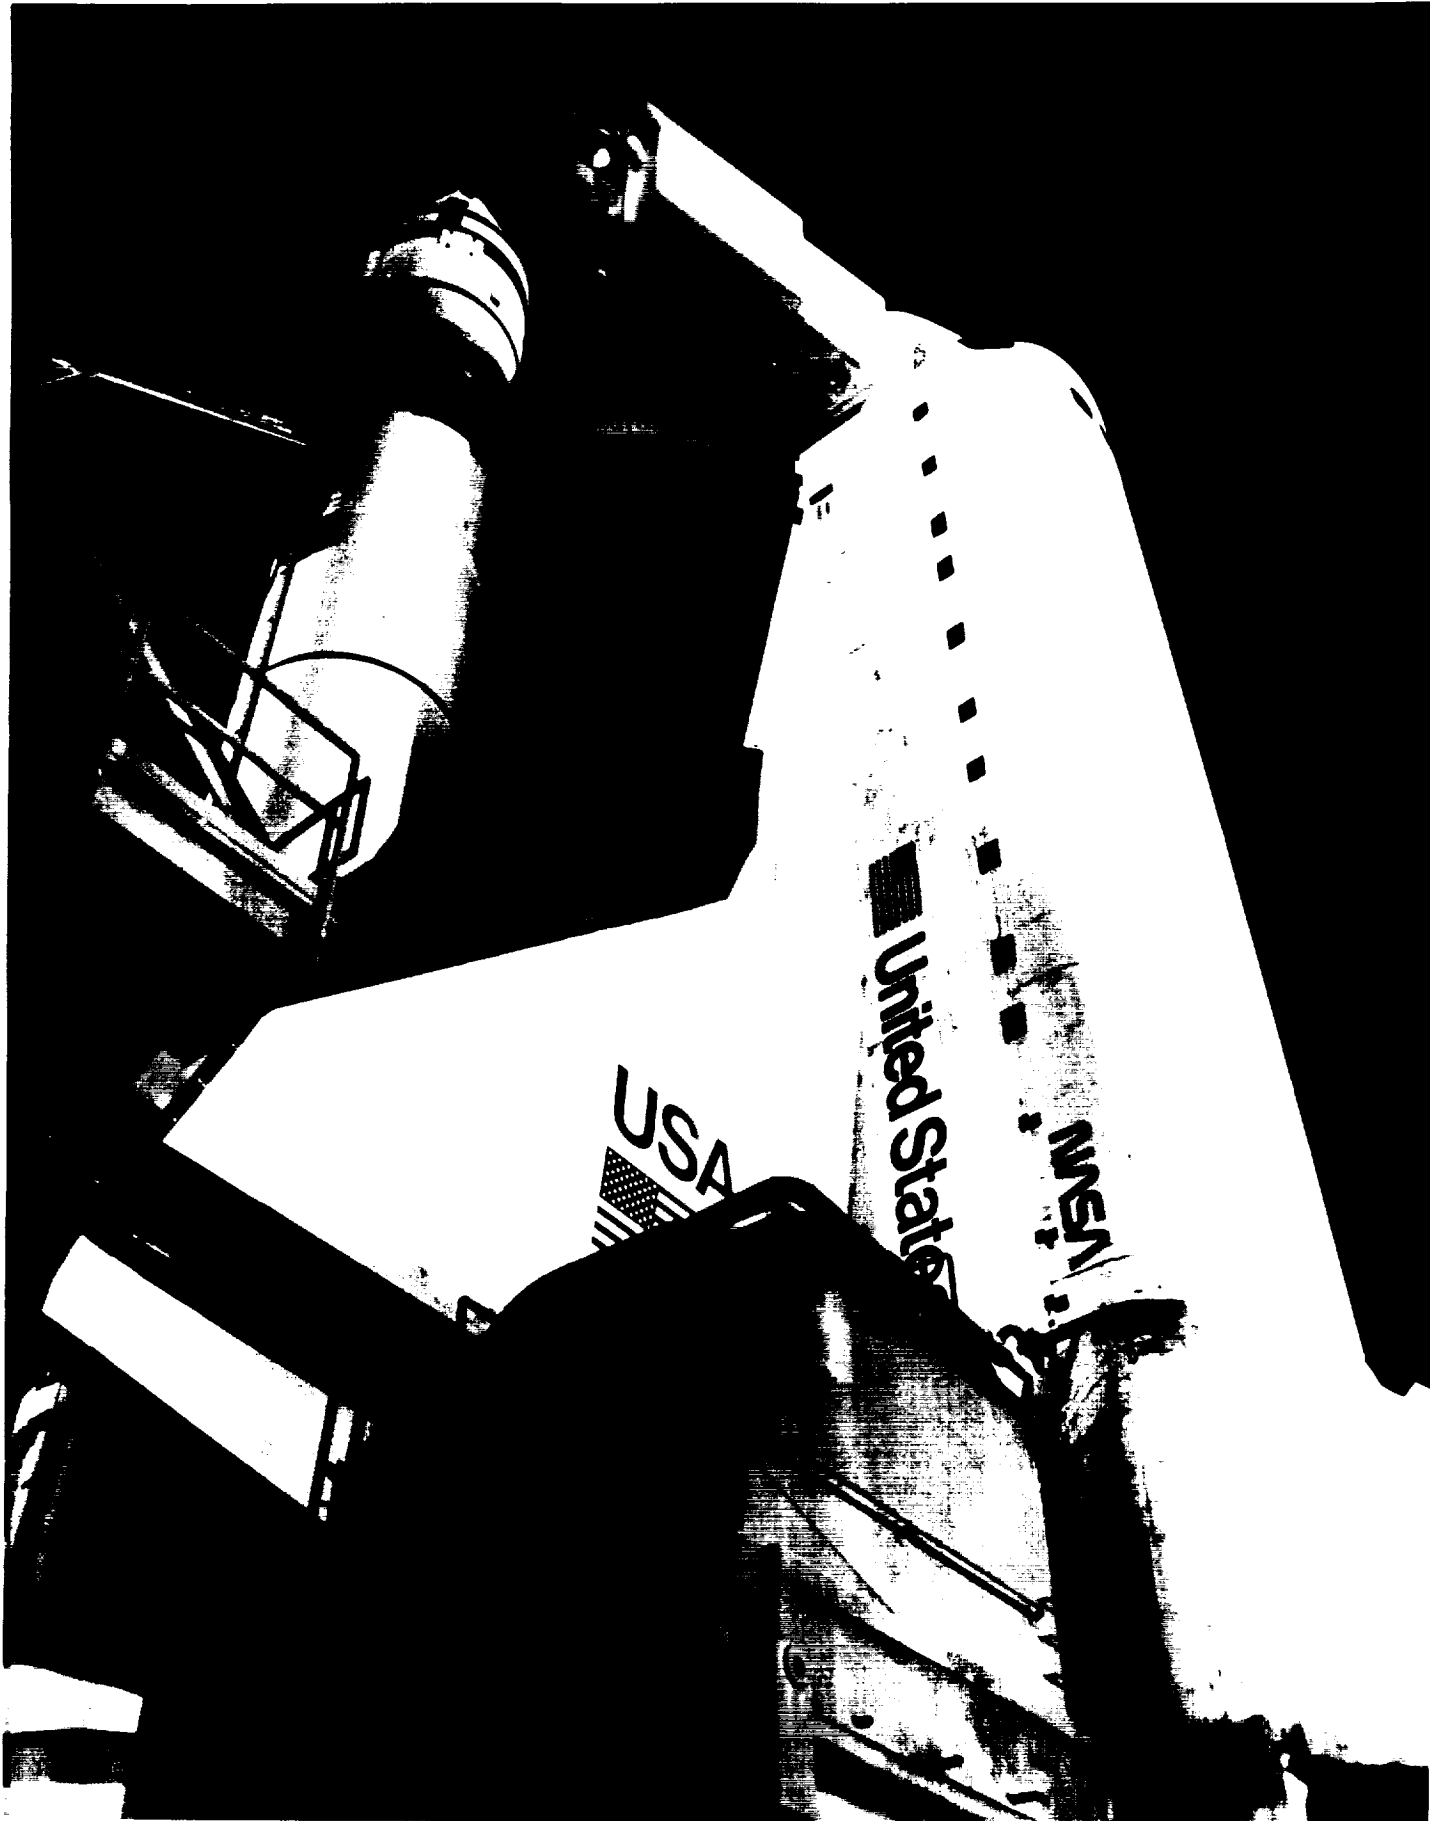
Overall view of OV-104, ET-44 (LWT 37), and BI-049 SRB's. There were no Launch Commit Criteria, OMRS, or NSTS-08303 violations

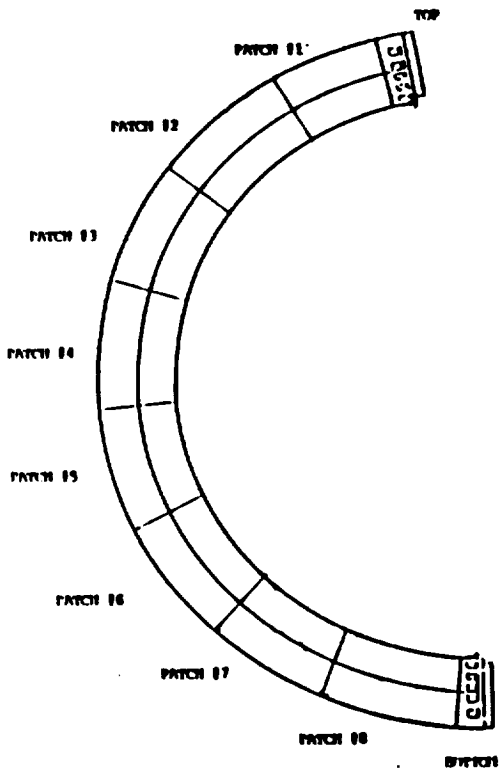
DMHS Blanket
showing sacrificial patch position

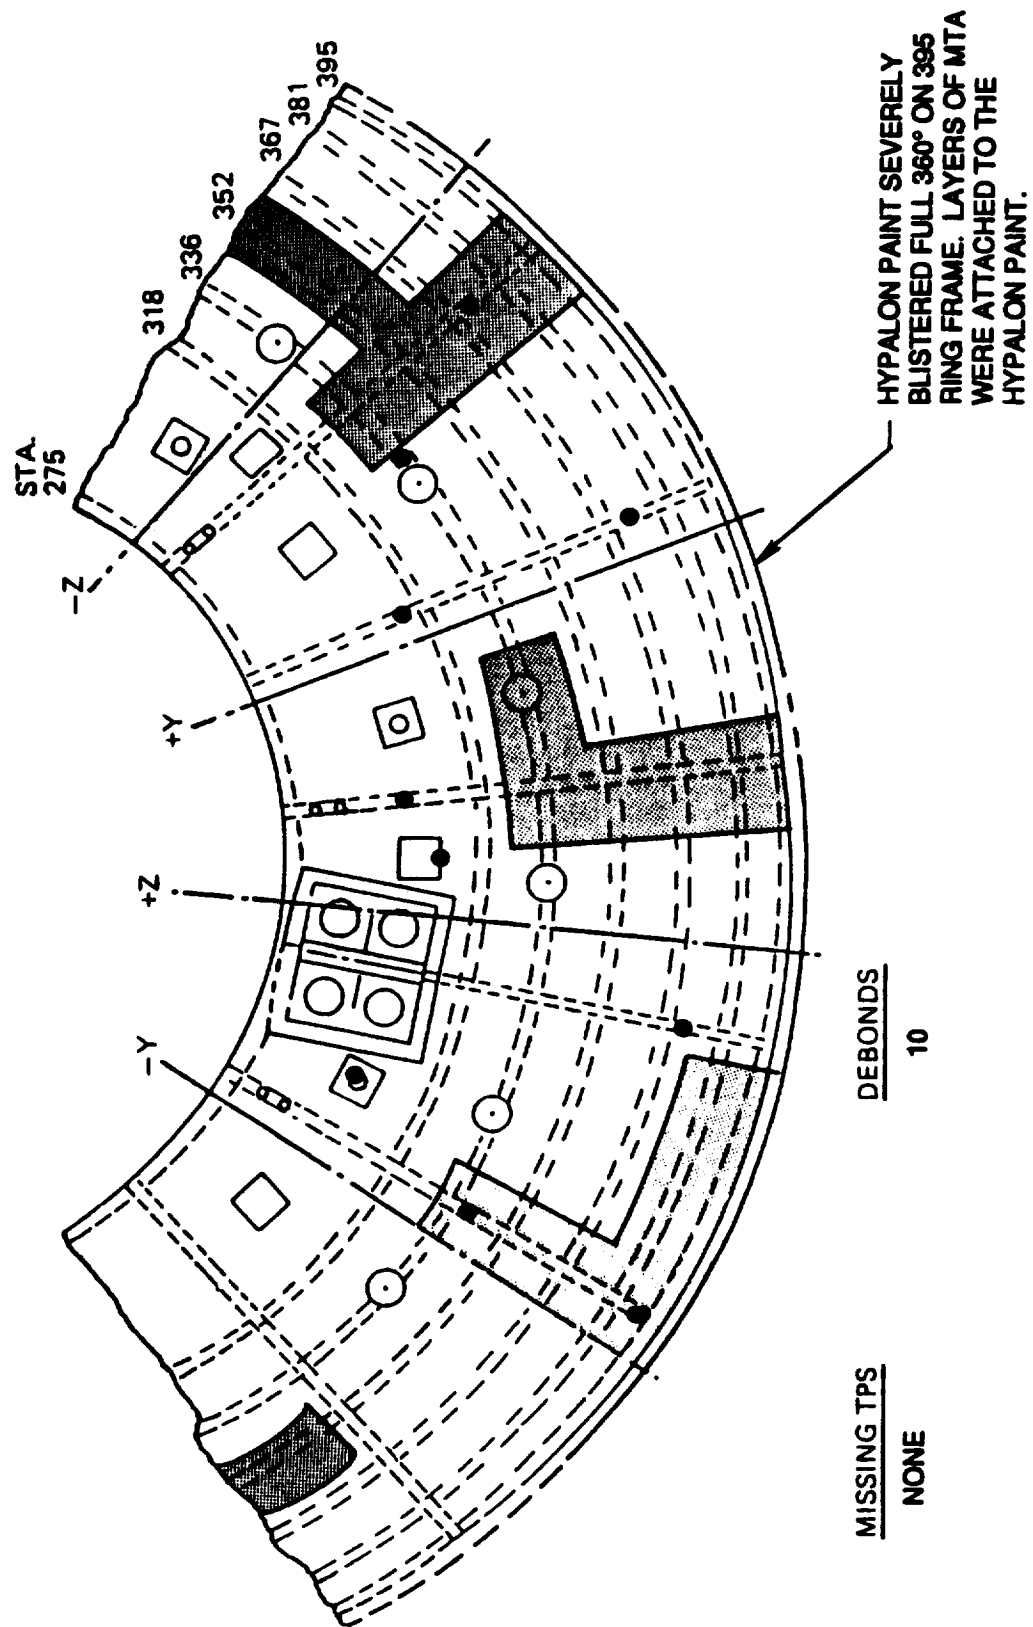
FIGURE 4. RIGHT SRB FRUSTUM

The RH frustum was missing no TPS but had 10 MSA-2 debonds over fasteners (Figure 4). The Hypalon paint was severely blistered and peeling the full circumference of the 395 ring frame and around the BSM's. The blisters averaged 2-3 inches in diameter and were generally ruptured. Layers of MTA adhered to the peeled Hypalon paint. PR PV6-214863 was taken to investigate the problem. All BSM aero heatshield covers were locked in the fully opened position. No hardware was missing from the frustum that could have caused the damage to RCC panel #10 on the Orbiter right wing leading edge.

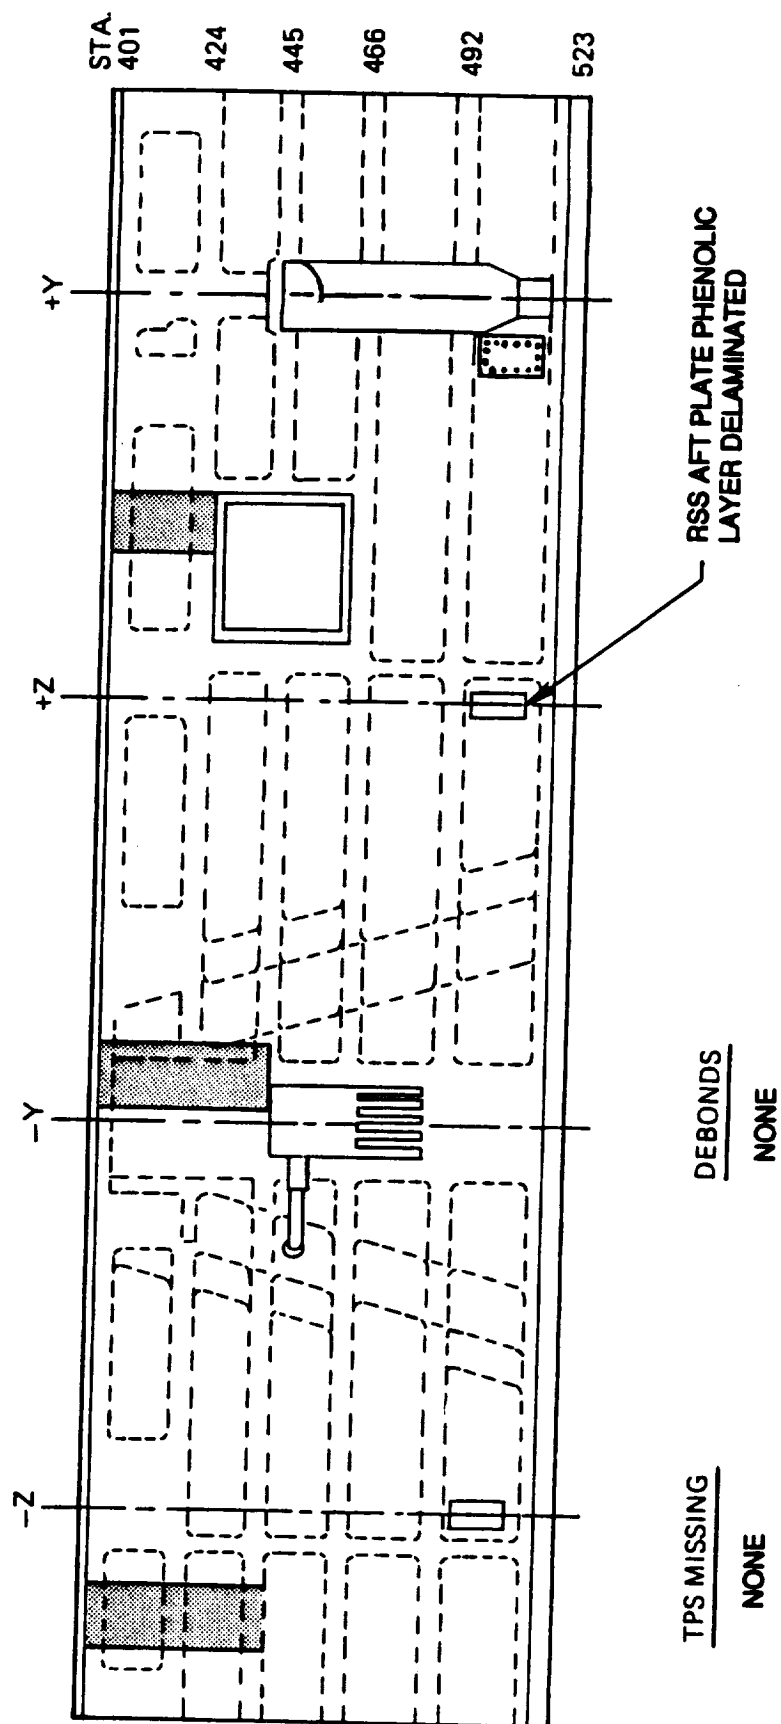
FIGURE 5. RIGHT SRB FWD SKIRT

The RH forward skirt exhibited no debonds or missing TPS (Figure 5). The phenolic plates on both RSS antennae were intact though the phenolic plate material on the +Z antenna was delaminated. The forward separation bolt and electrical cables appeared to have separated cleanly. No pins were missing from the frustum severance ring. No hardware was missing that could have caused the damage to RCC panel #10 on the Orbiter right wing leading edge.

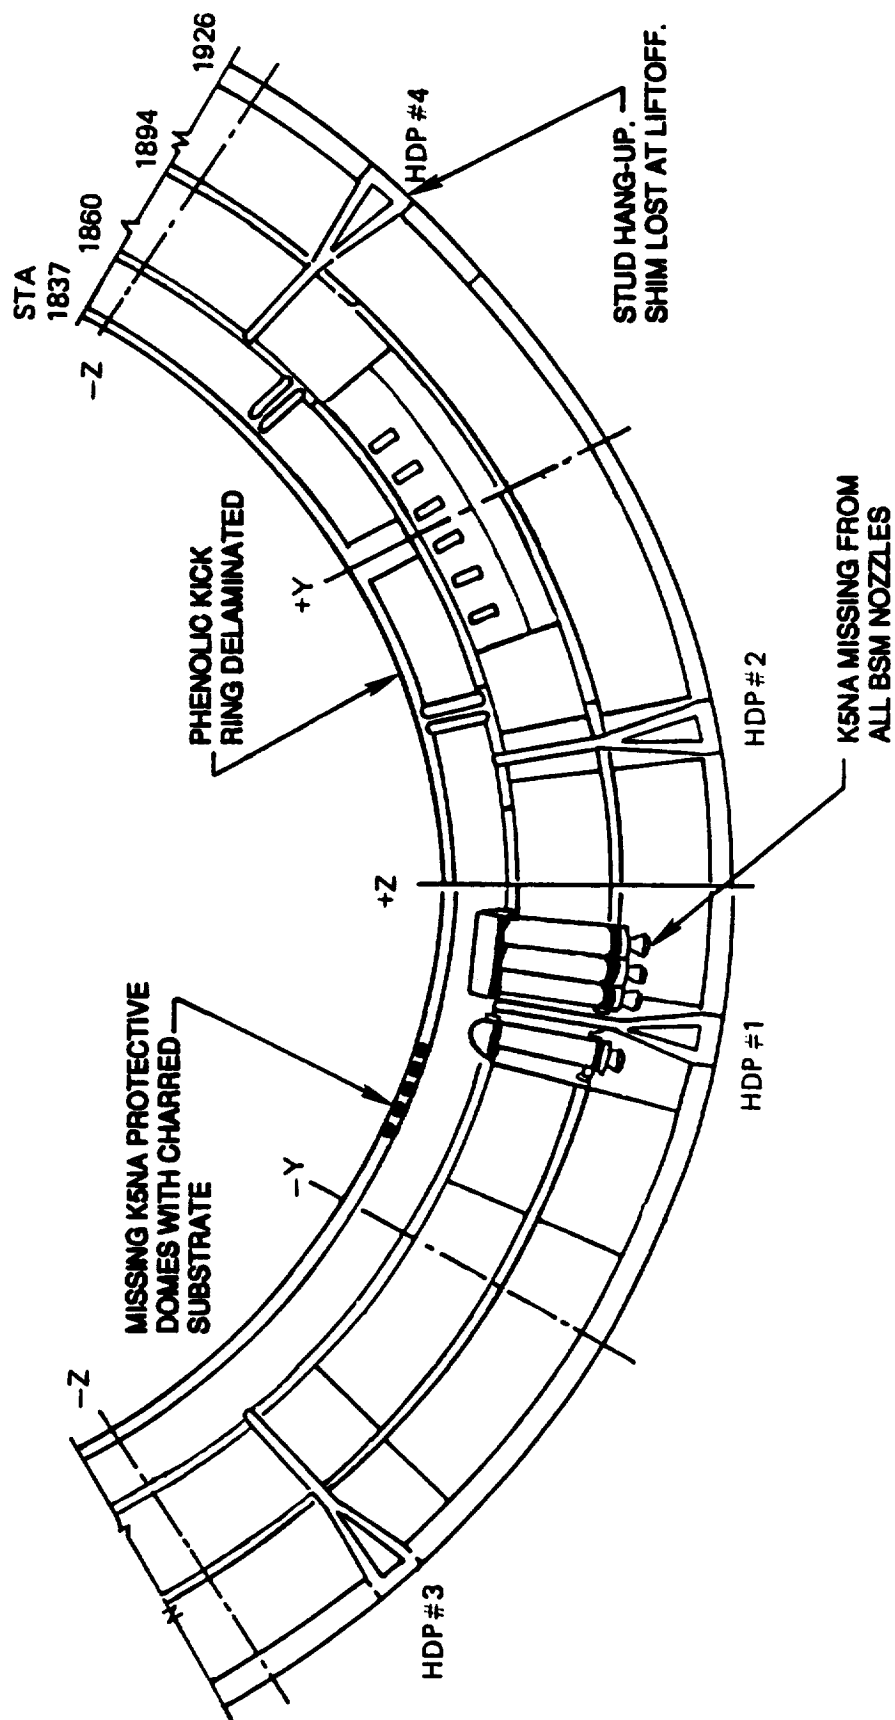
FIGURE 6. RIGHT SRB AFT SKIRT EXTERIOR TPS

The phenolic material on the kick ring had delaminated. Several K5NA protective domes were lost from bolt heads on the aft side of the phenolic kick ring prior to water impact (sooted substrate). K5NA was missing from all aft BSM nozzles (Figure 6). The aft skirt acreage TPS was generally in good condition. Squawk 45-011 was taken against two 1-inch gashes in the MSA-2 over fastener sealant two feet to the outboard side of the triple BSM housing. Slight sooting covered both areas. One theory suggested the gashes were caused by the same particles that had impacted the Orbiter RCC panel #10 on the right wing leading edge. Two MSA-2 samples were removed for evaluation, which revealed no charring or heat effects under the layer of sooting. The investigation concluded that the gashes occurred during SRB re-entry and descent and were not related to the Orbiter wing impact.

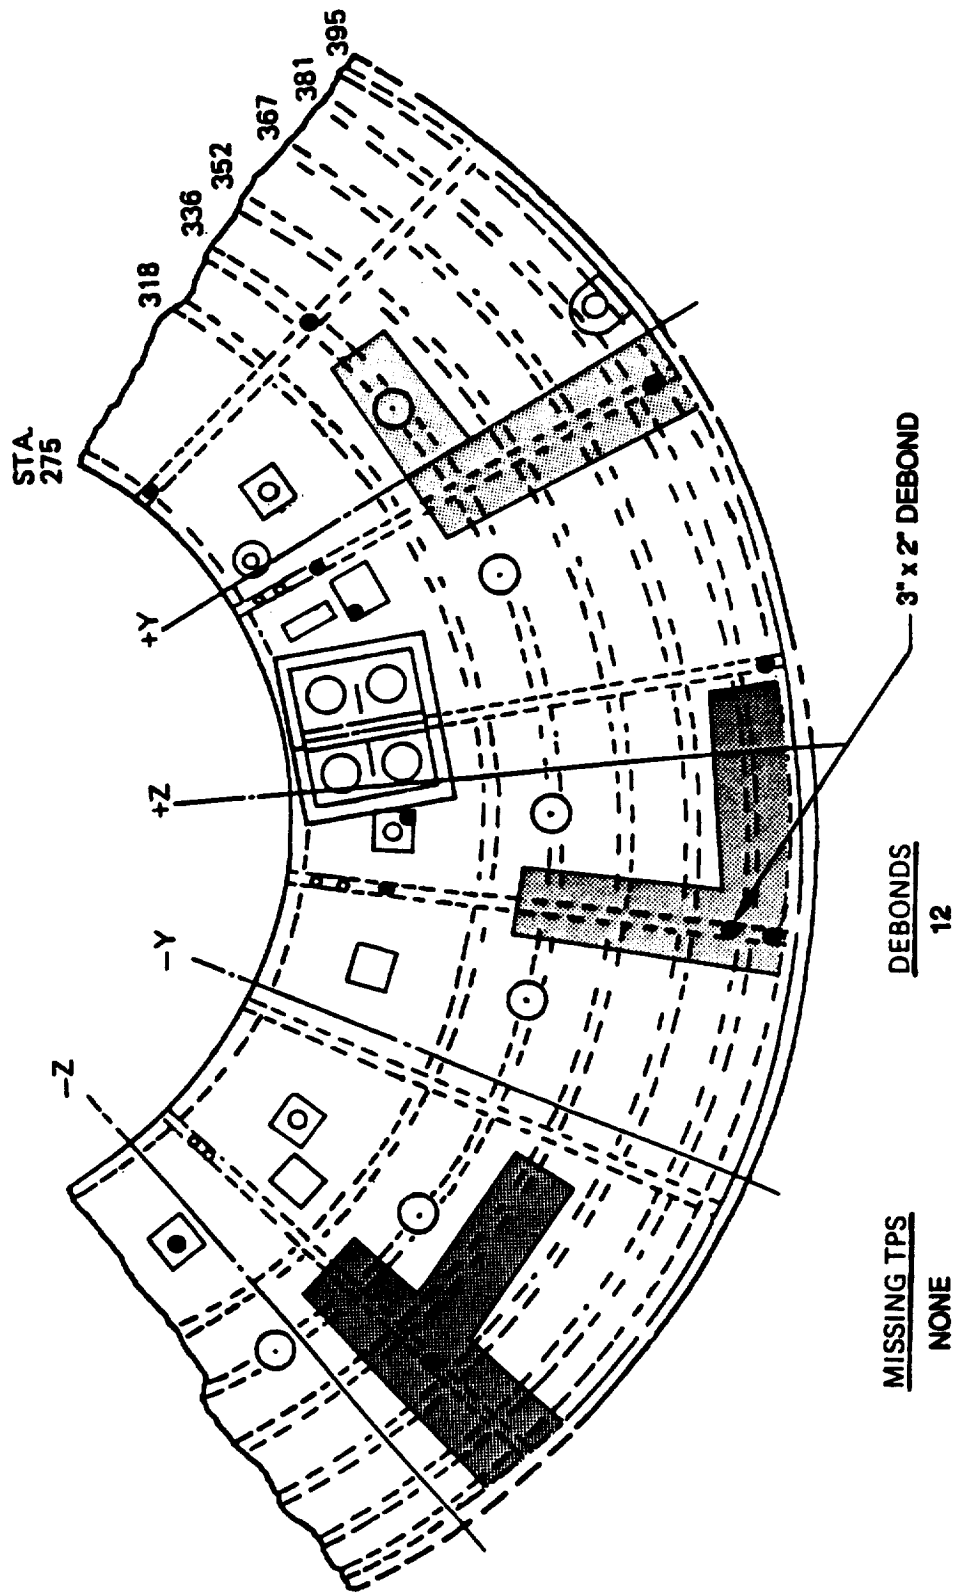
FIGURE 7. LEFT SRB FRUSTUM

The LH frustum was missing no TPS but had 12 MSA-2 debonds over fasteners. The largest debond measured 3"x2" and was located between the -Y and +Z axes near the 381 ring frame. There was minor localized blistering of the Hypalon paint (Figure 7). The BSM aero heat shield covers were locked in the fully opened position. However, three of the cover attach rings had been bent at the hinge by parachute riser entanglement.

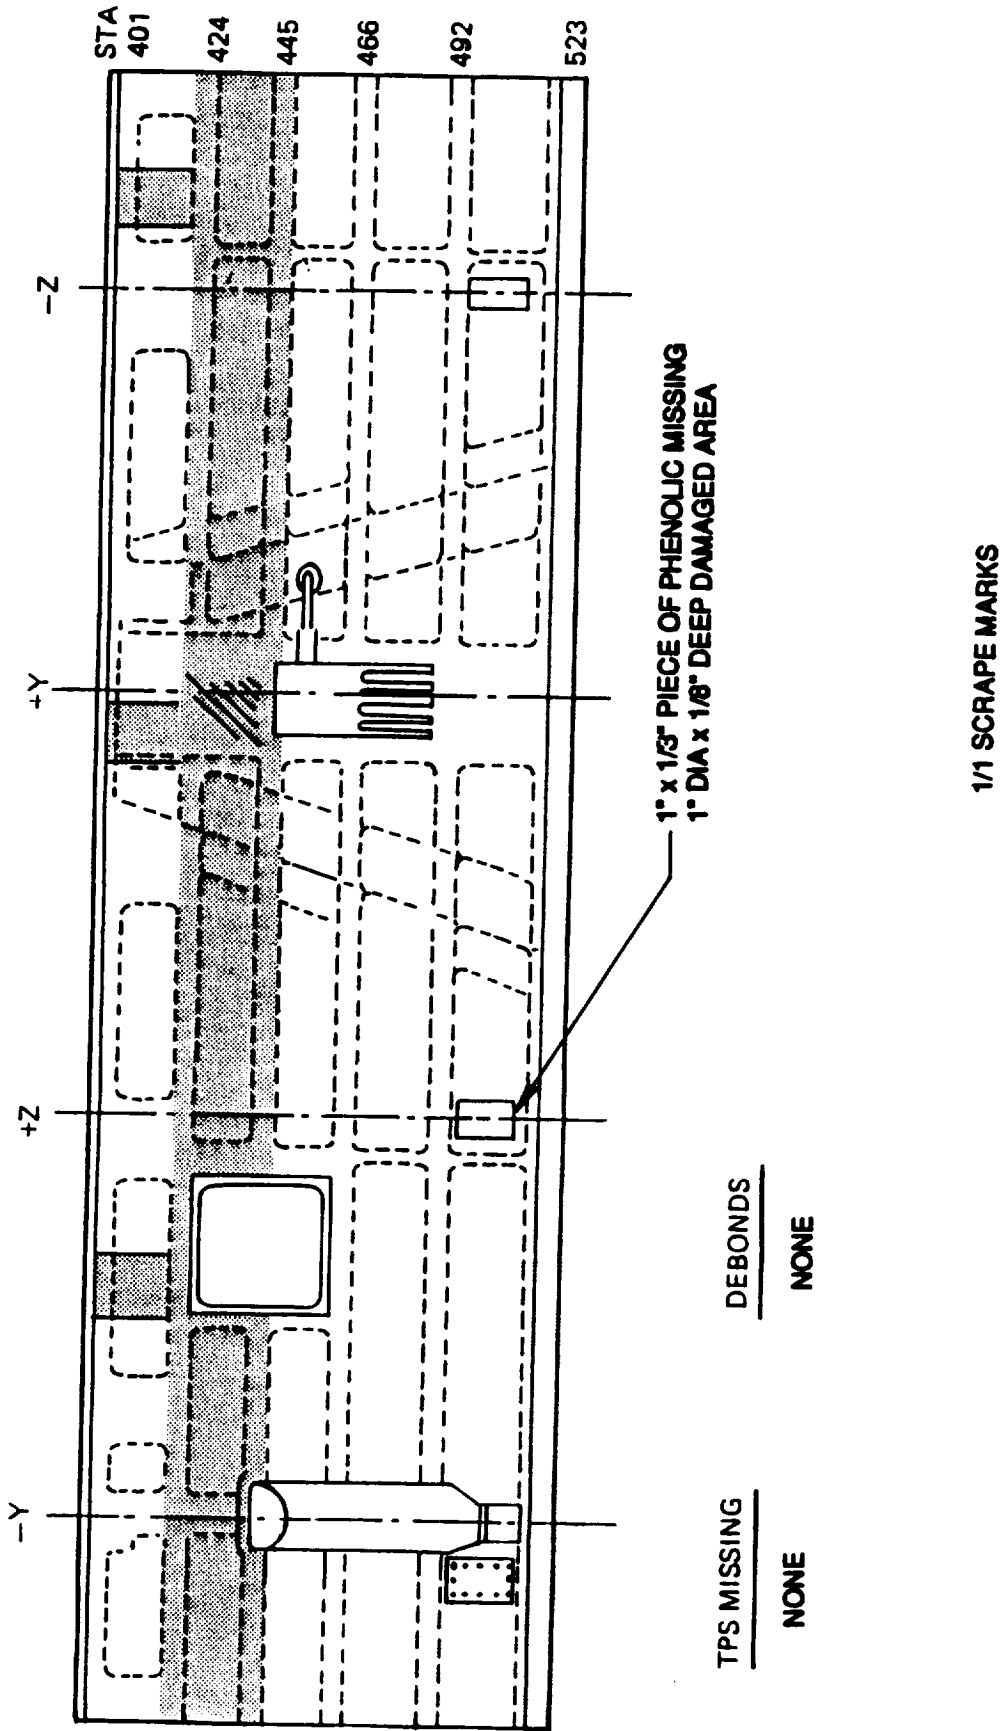
FIGURE 8. LEFT SKIRT AND SKIRT

The LH forward skirt exhibited no debonds or missing TPS. The phenolic plates on both RSS antennae were intact (Figure 8). The forward separation bolt and electrical cables appeared to have separated cleanly. No pins were missing from the frustum severance ring. Minor blistering of the Hypalon paint occurred near the ET/SRB attach point.

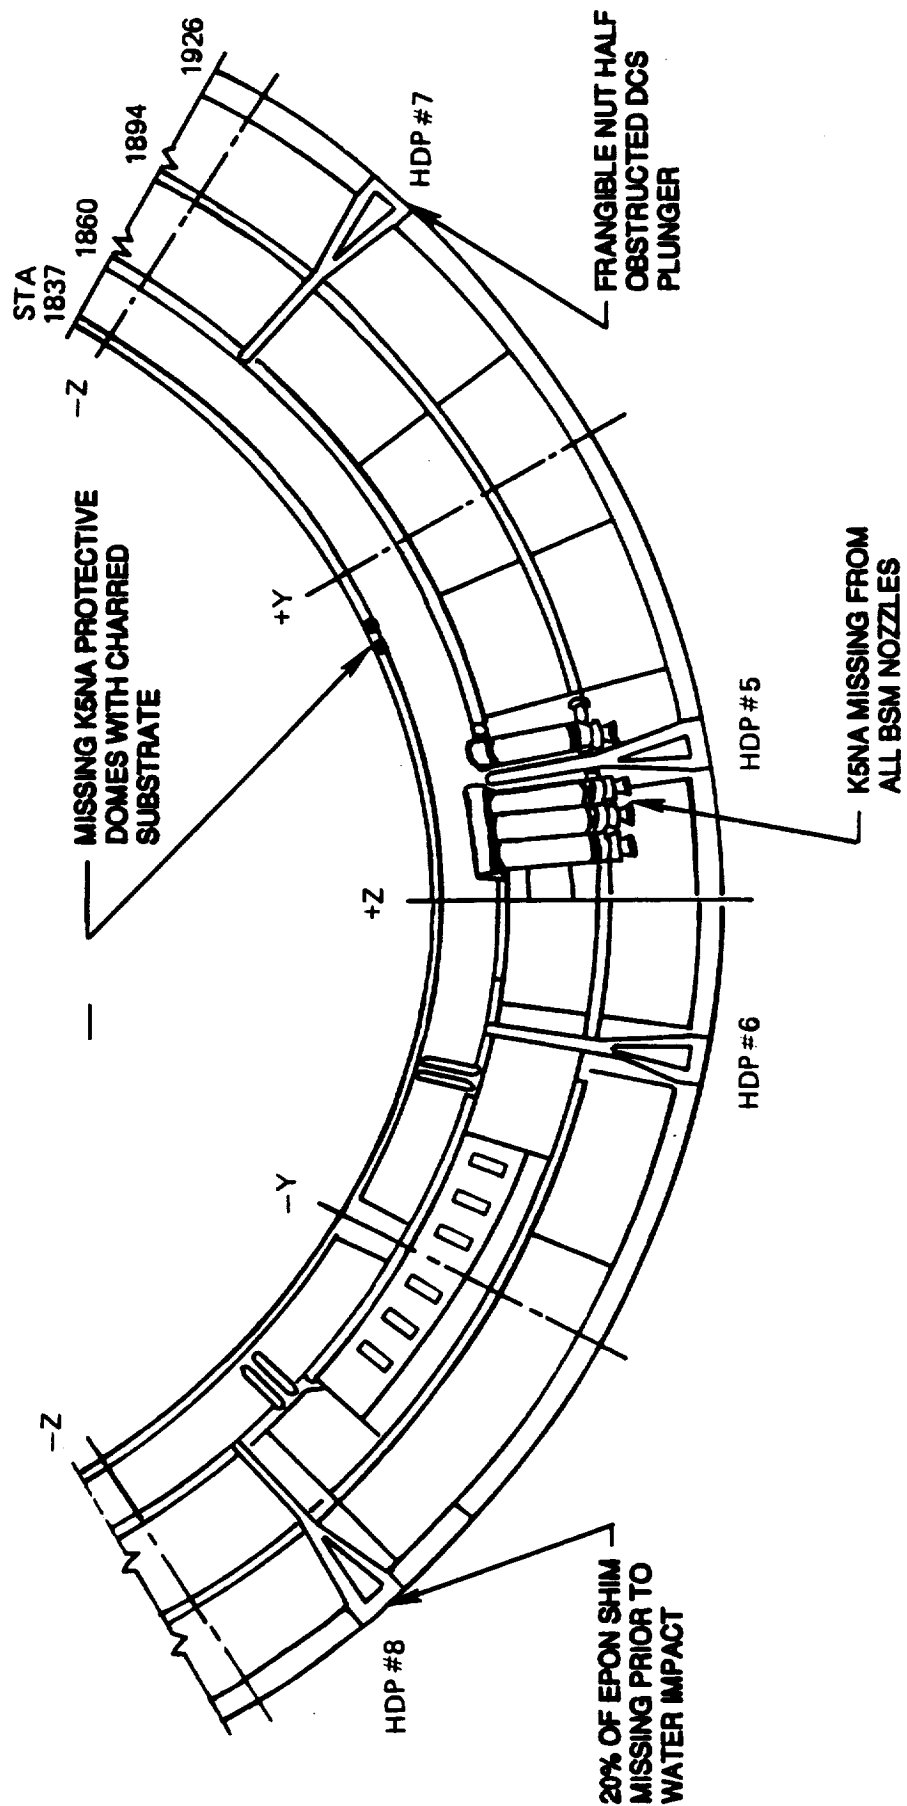
FIGURE 9. LEFT SRB AFT SKIRT EXTERIOR TPS

Two K5NA protective domes were missing from bolt heads on the aft side of the phenolic kick ring prior to water impact (charred substrate). K5NA was missing from all aft BSM nozzles (Figure 9). The aft skirt acreage TPS was in good condition.

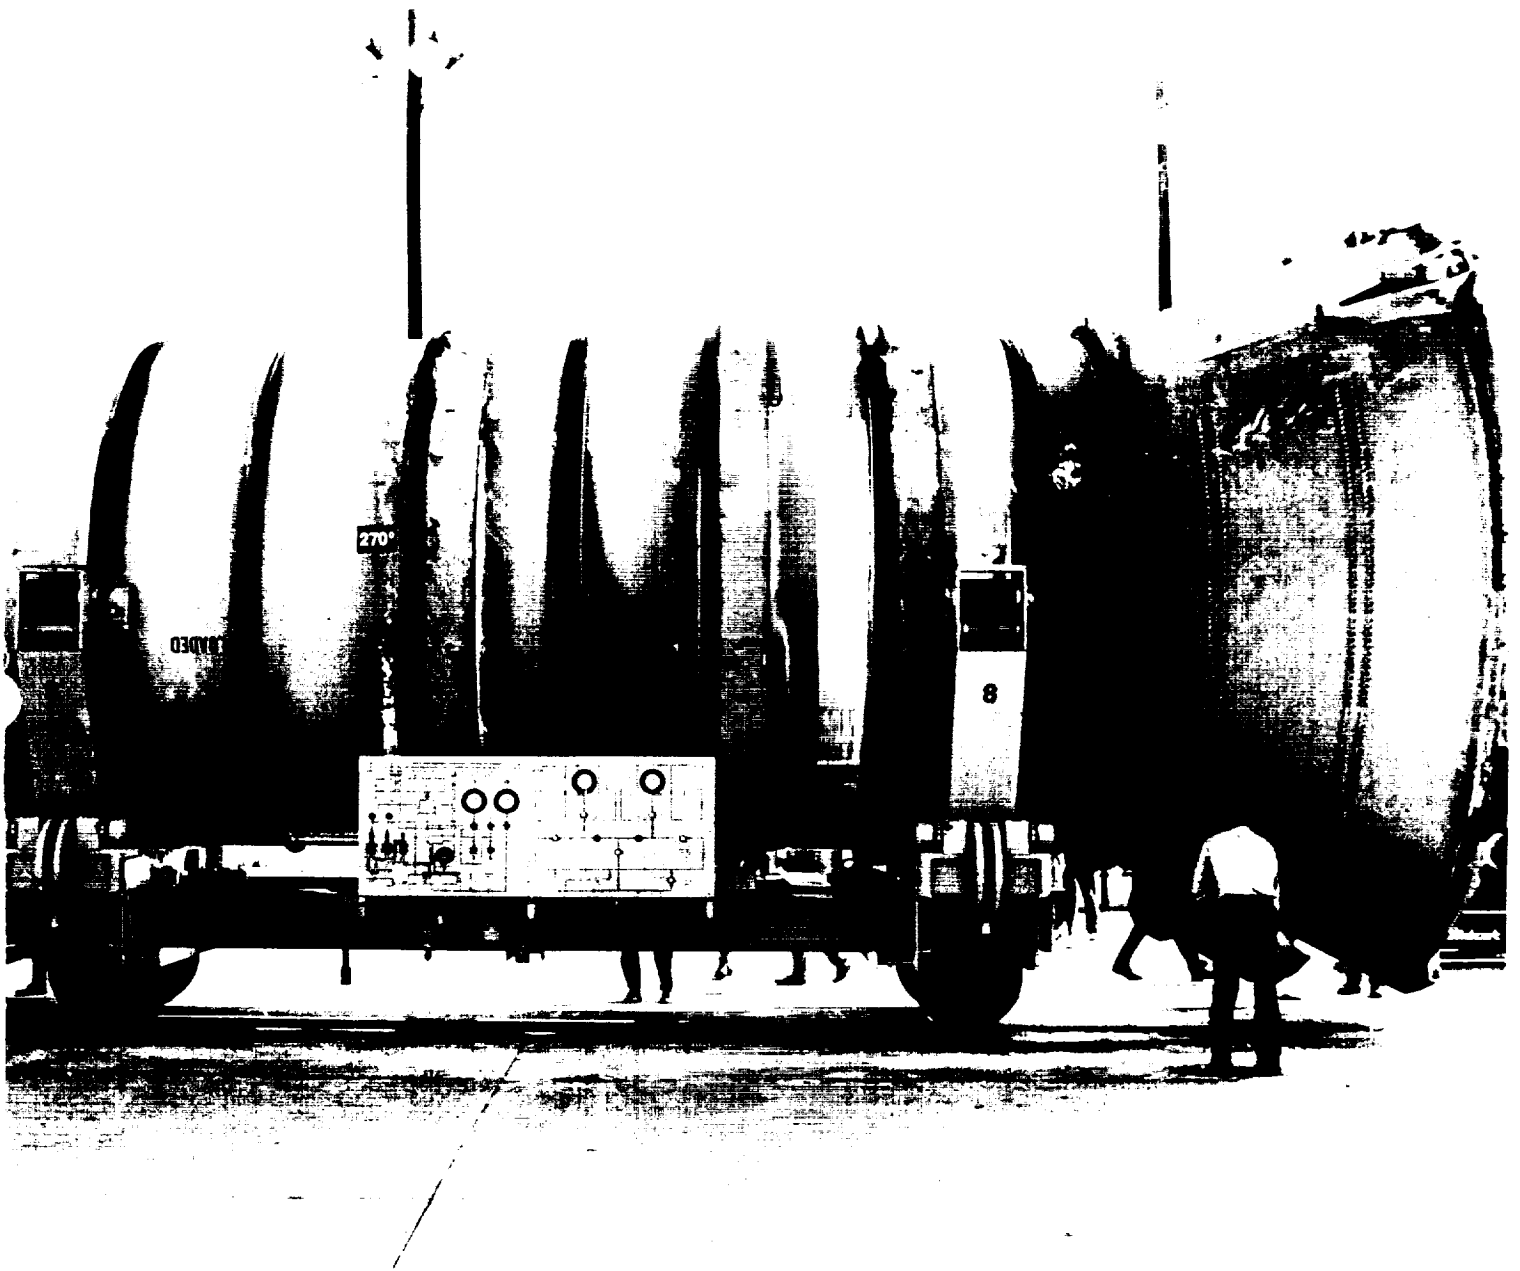
Post flight condition of the LH aft booster/aft skirt. The aft skirt acreage TPS was sooted but generally in good condition. The ET/SRB aft struts, IEA, ETA ring, and all three aft booster stiffener rings appeared undamaged.

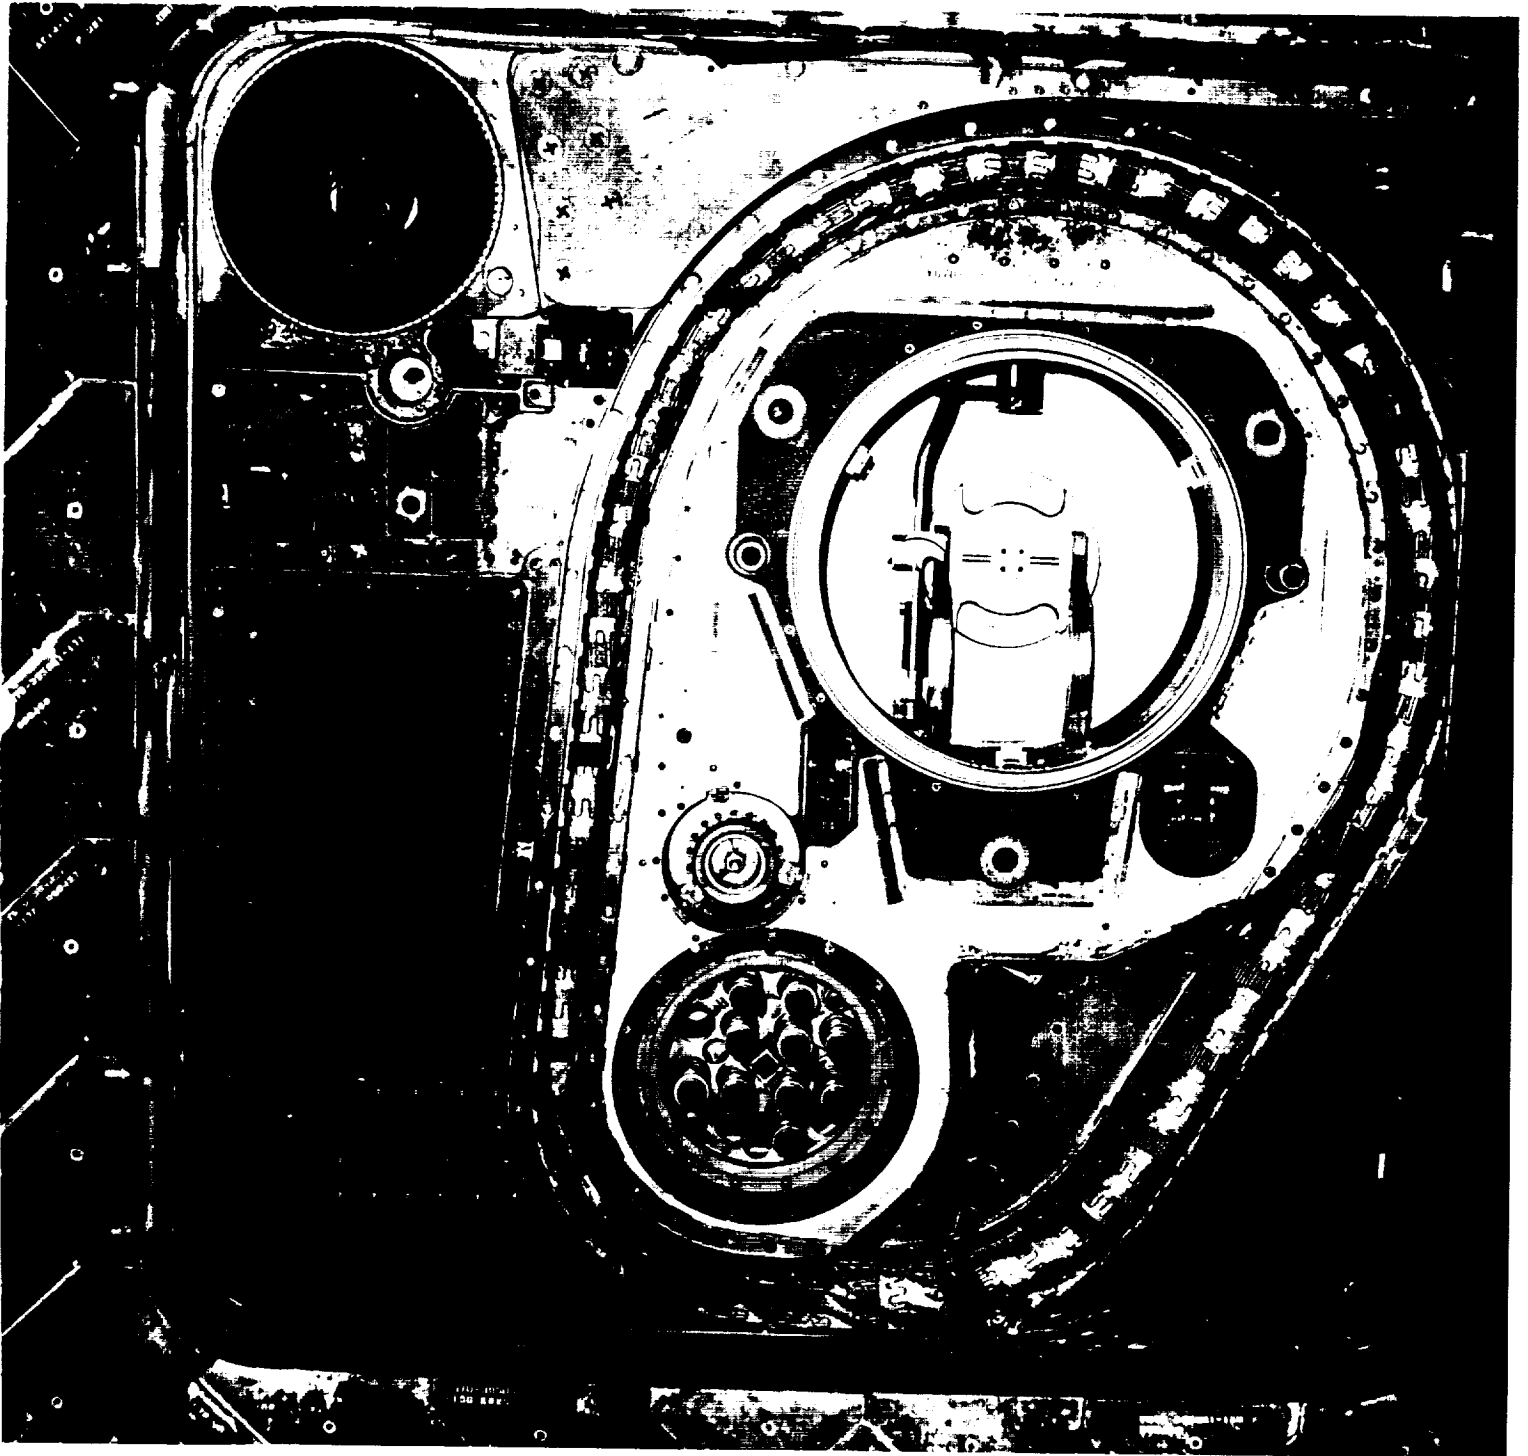
Overall view of the L02 ET/ORB umbilical

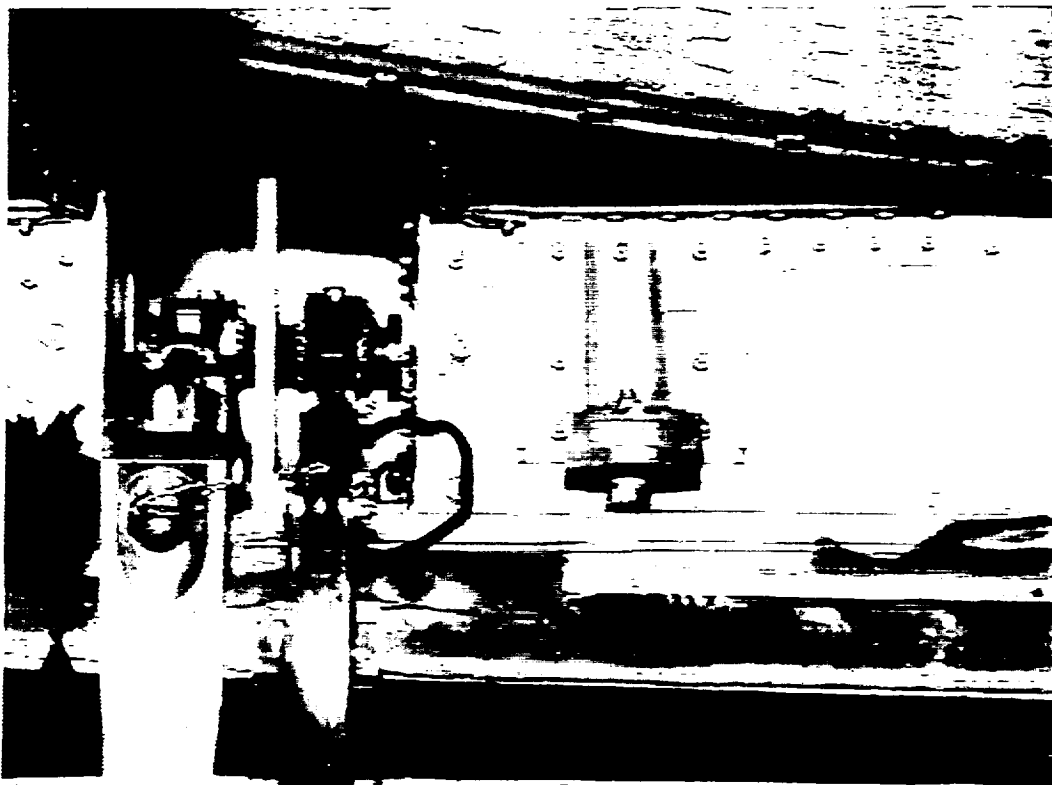
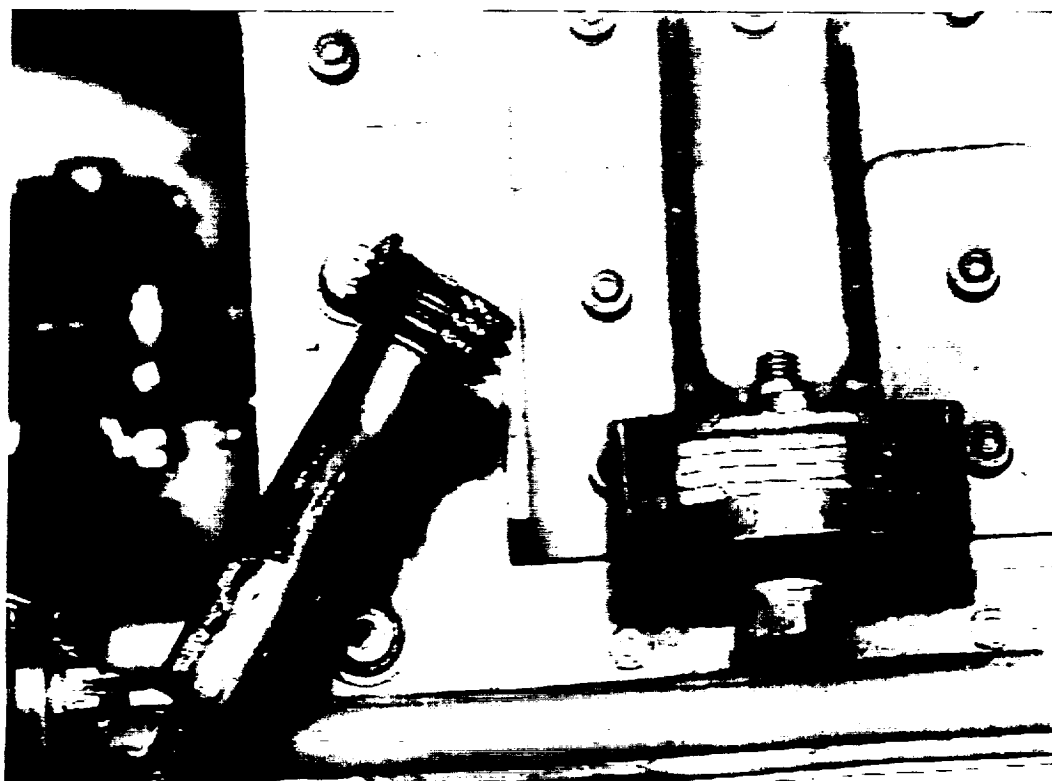
Because of the obstruction of the EO-3 plunger, a detonator booster from the separation system was allowed to escape and was found in the ET door hinge cavity.

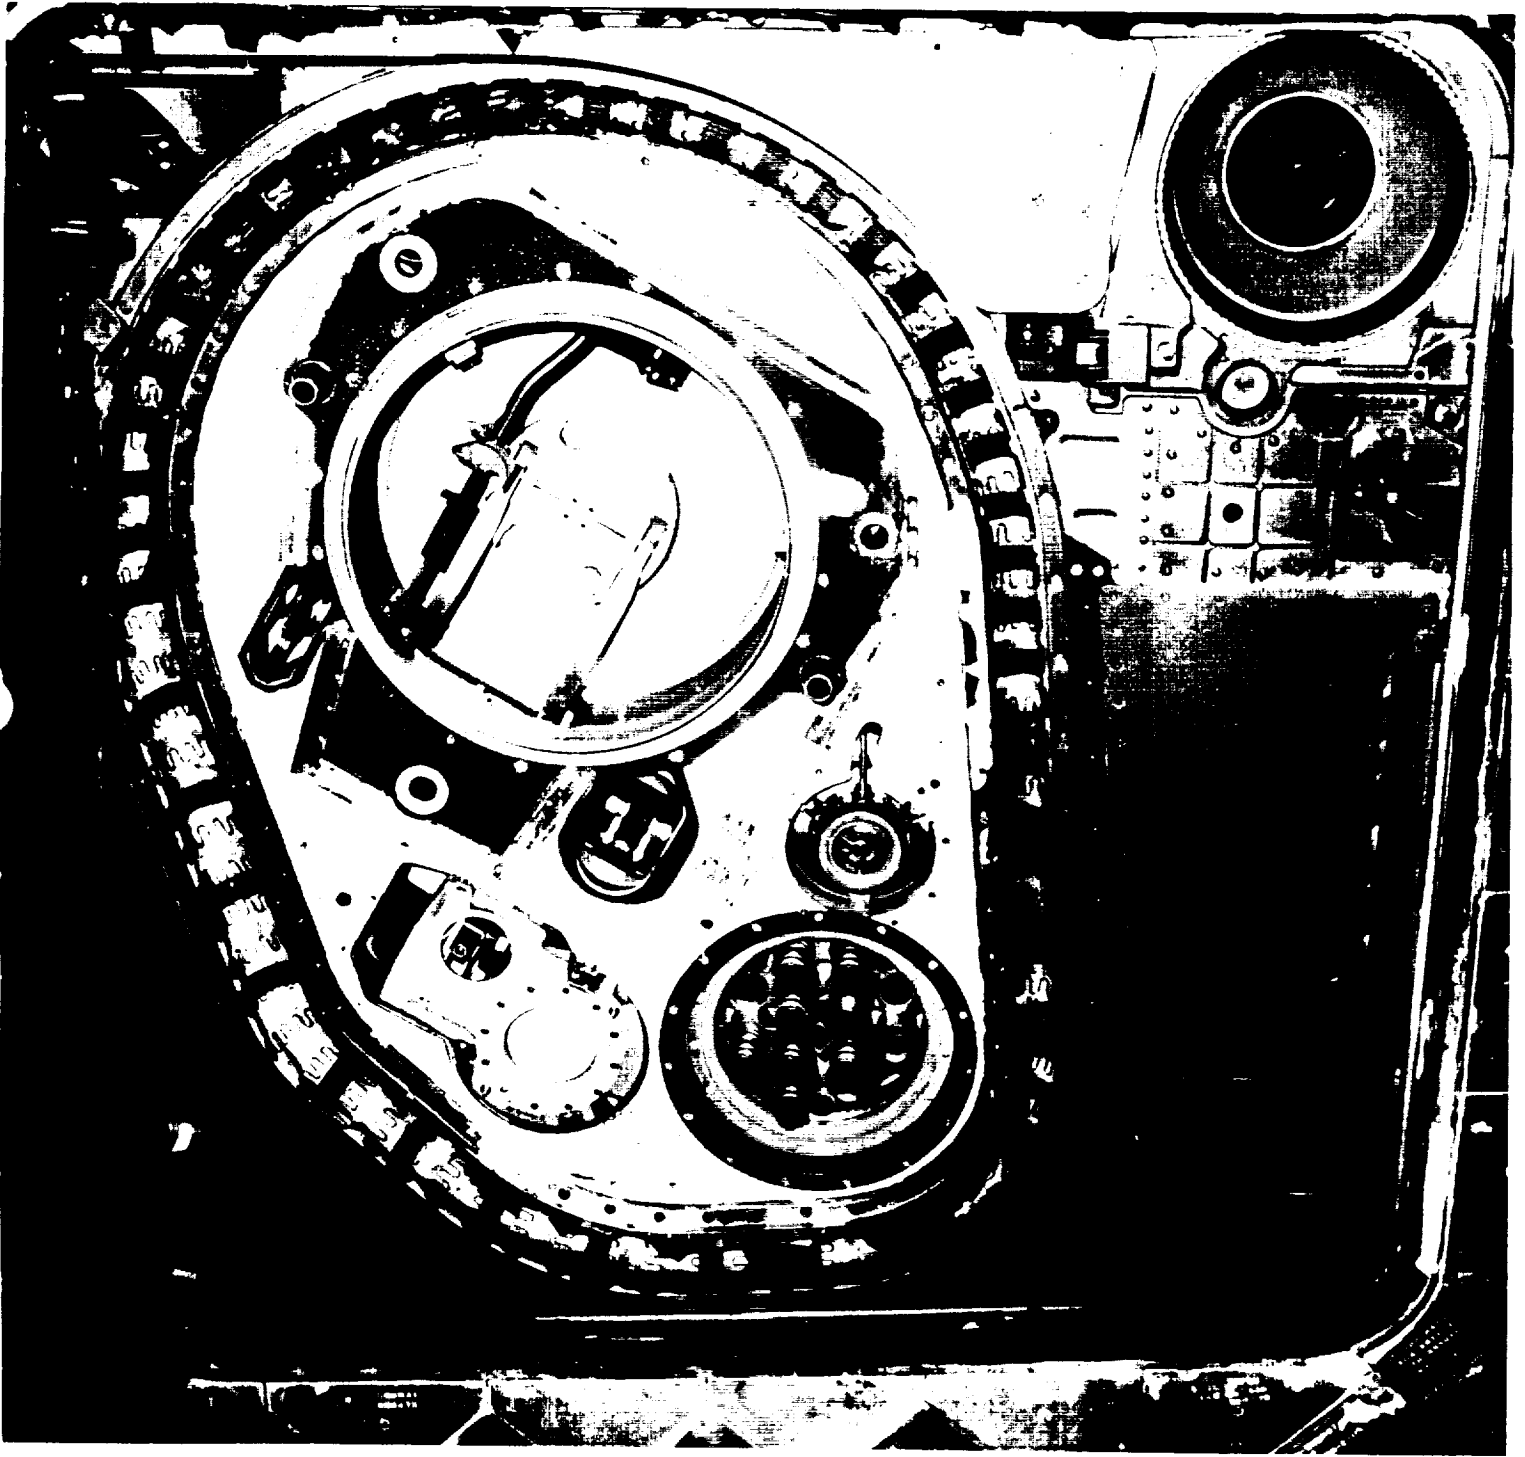
Overall view of the LH2 ET/ORB umbilical.

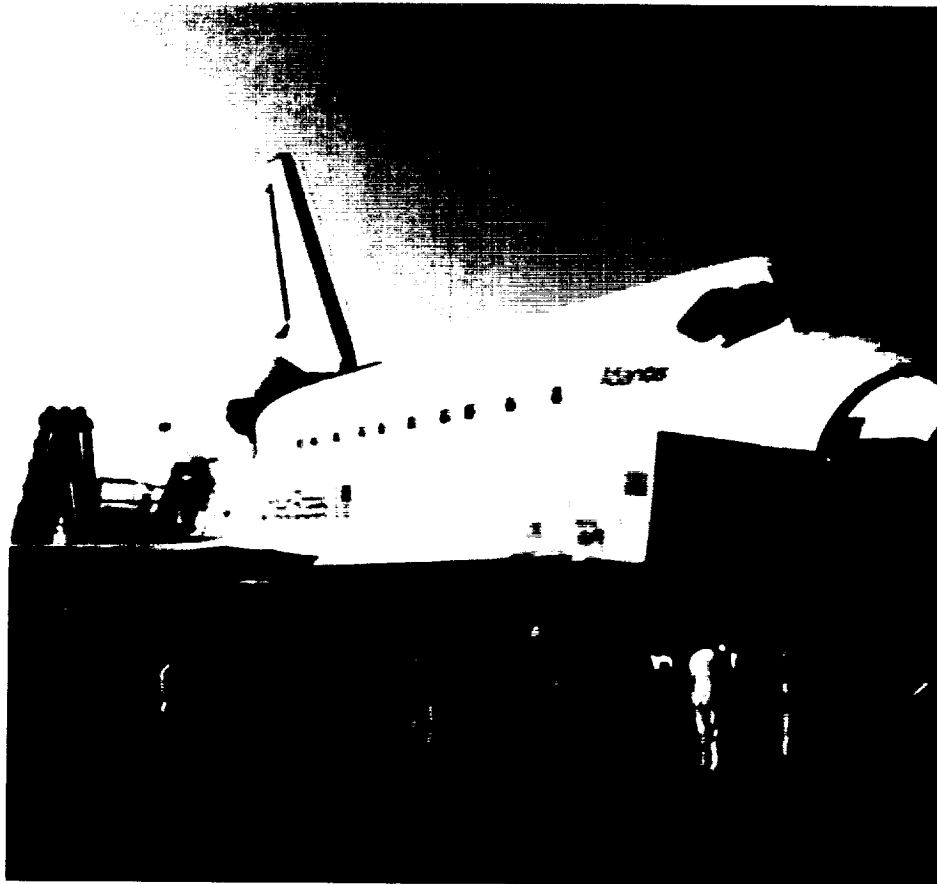
Figure 2.5.2 (A) Tile Damage Locations on the Orbiter

The post-landing inspection of the Orbiter revealed damage to the lower right nose area (tile nos. V070-39015-211 and V070-39015-212) and to the RCC panel #10 near the leading edge of the right wing. A review of launch tracker films E-052, E-054, E-057, E-059, E-205 and E-207 and all the landing videos was conducted to determine whether or not the damage could have been attributed to a previously seen event. No apparent debris source was seen on the films that might have led to the damage. Figure 2.5.2 (A) shows a general view of the damaged areas. Figure 2.5.2 (B) shows detailed views of the RCC damage.

This photograph taken during the post-landing inspection of the Orbiter shows a general view of the area where RCC damage was seen. See Figure 2.5.2 (B) for more detailed views of the damage.
